# UNINTENTIONAL RF RADIATION AND RECEPTION IN COAXIAL CABLE TRANSMISSION LINES DUE TO SHEATH CONDUCTOR FAULTS

THESIS

Master of Science  
In  
Electrical Engineering

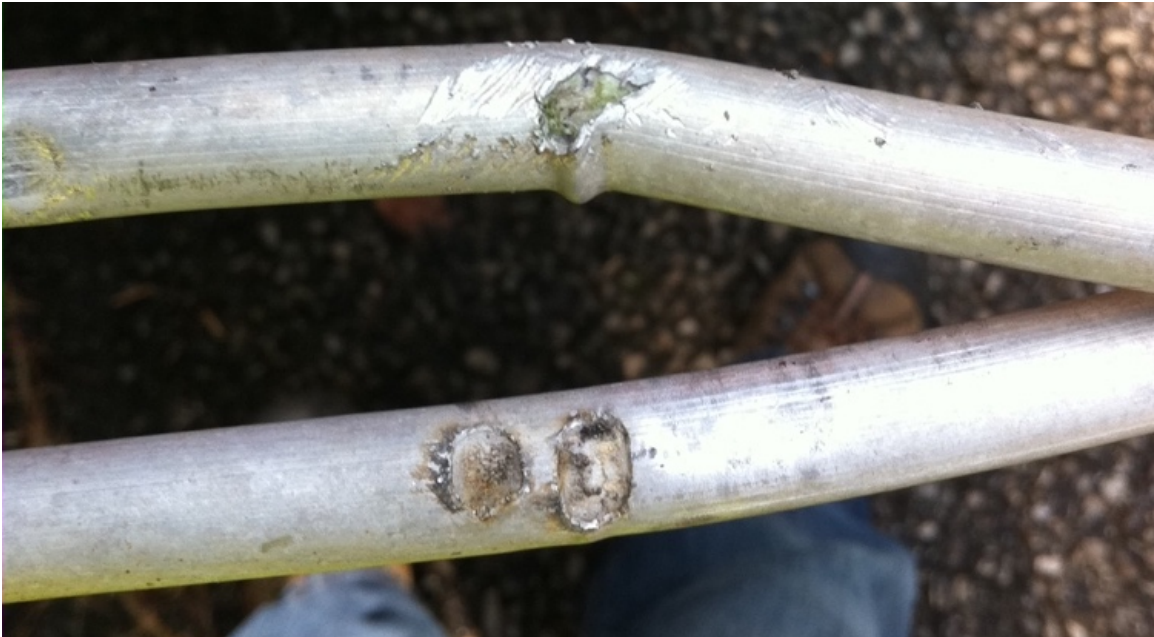
Fig. 2. Abrasion from wind motion (top) and holes from electrical arcing (bottom)

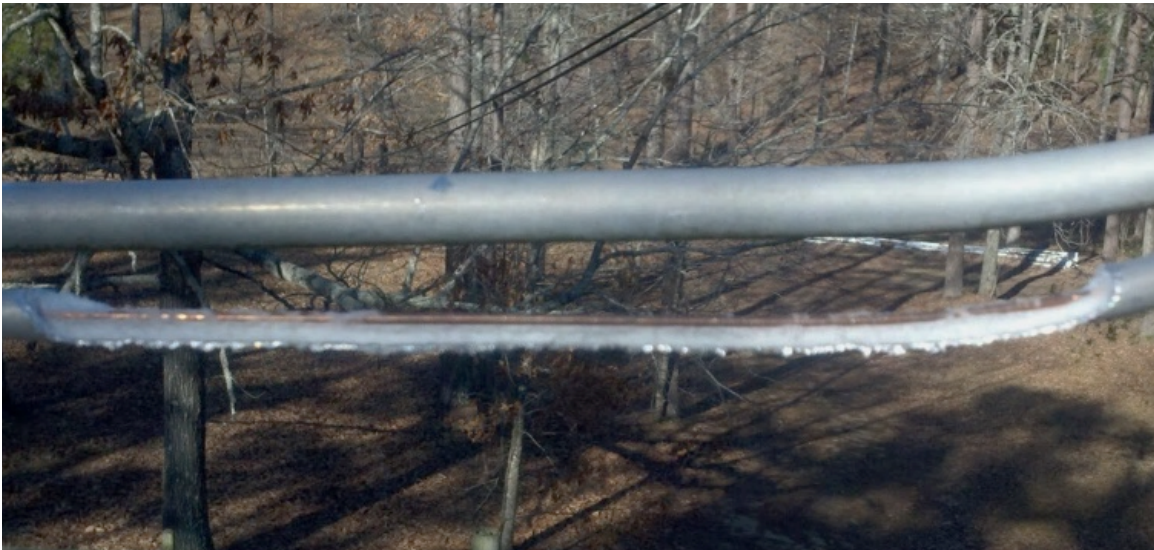
Fig. 10. Squirrel-damaged coaxial cable in an HFC network

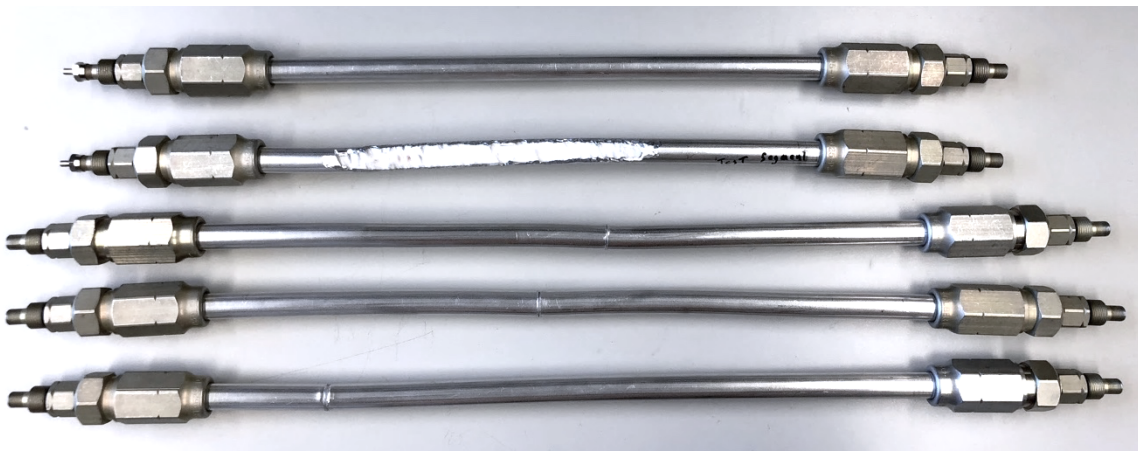
Fig. 11. Test cable segments 00 – 04 (top to bottom)

In the case of samples 03 and 04, the radial crack was generated in the same method used for 02, detailed above, but the cracked cable was manipulated until a gap of approximately 1mm was present between the two, now fully disjoint, sections of sheath conductor. Any small fragments of the aluminum conductor that might act to bridge the gap were removed, and sheath discontinuity was verified using an ohm-meter.
